*See back  
page for 1473*  
**HIGHLAND LAKE DAM**

**PHASE I INSPECTION REPORT  
NATIONAL DAM SAFETY PROGRAM**

NJ 00240

**DEPARTMENT OF THE ARMY  
PHILADELPHIA DISTRICT, CORPS OF ENGINEERS  
CUSTOM HOUSE - 2D & CHESTNUT STREETS  
PHILADELPHIA, PENNSYLVANIA 19106  
AUGUST 1978**

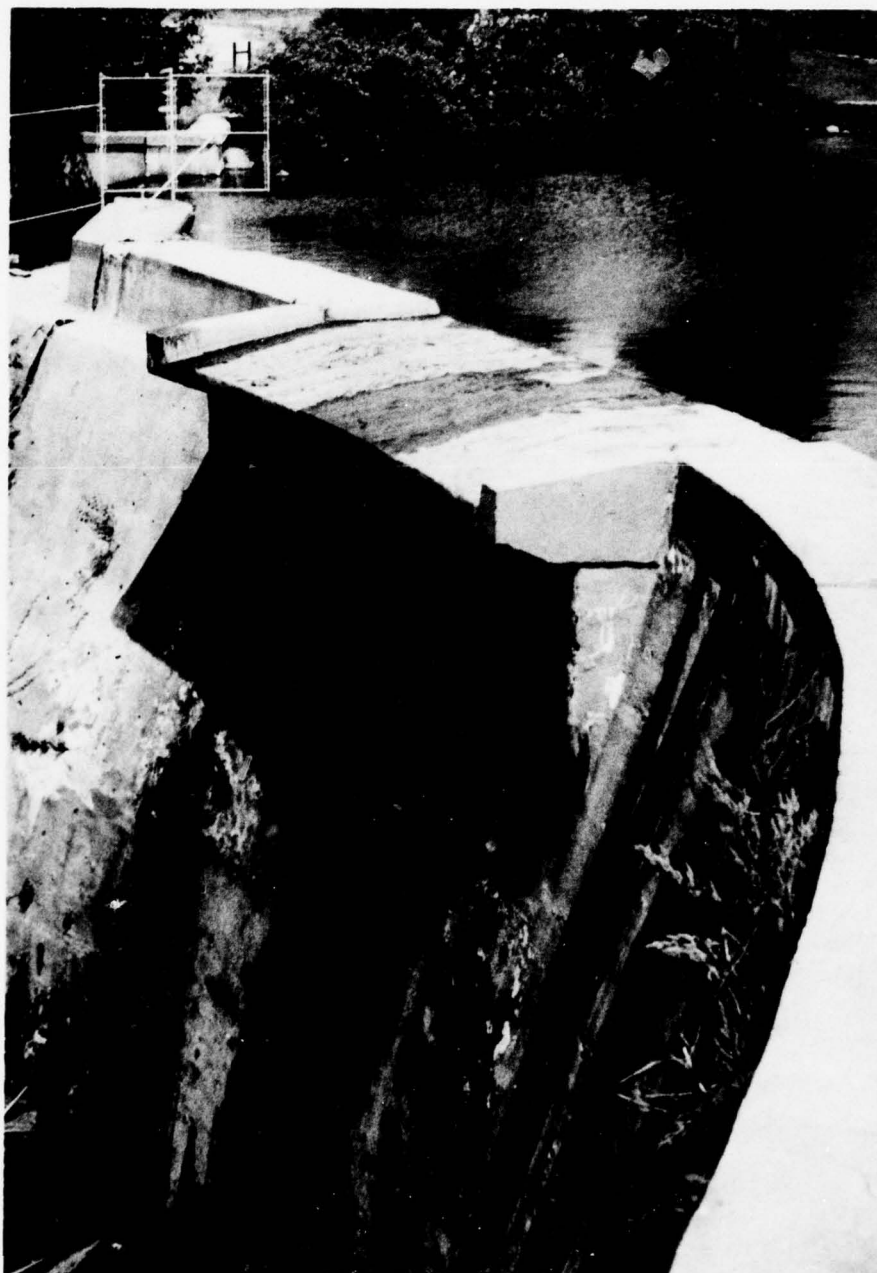
Dam and main spillway; service spillway is on right abutment at far shoreline.

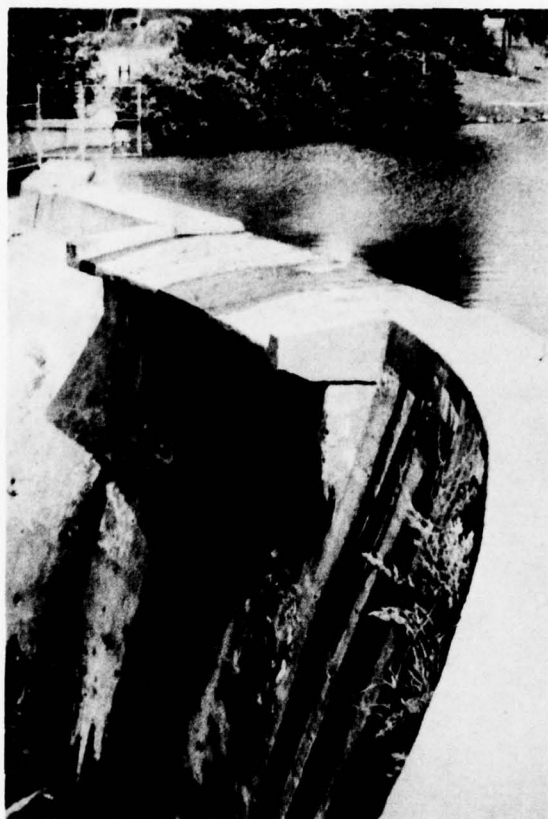
Photo 1 - View along crest of dam from left abutment showing main spillway and service spillway on right abutment.

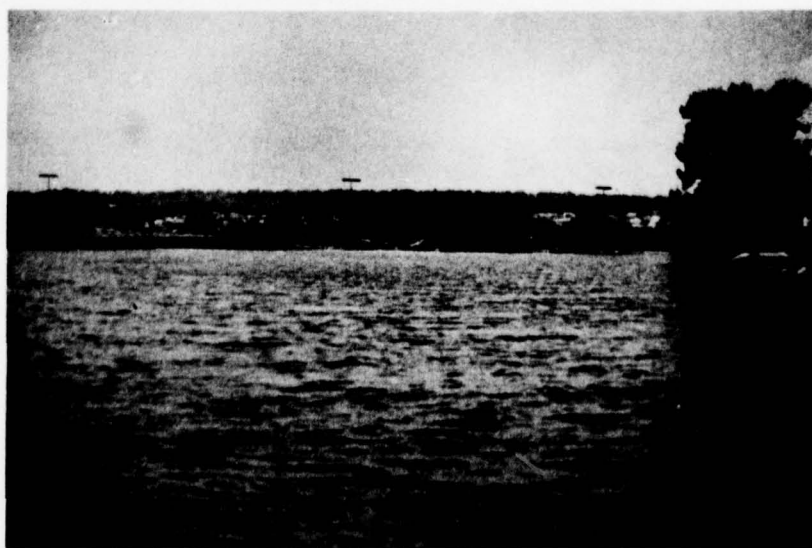
Photo 2 - View of dam and left abutment from upstream right shoreline.

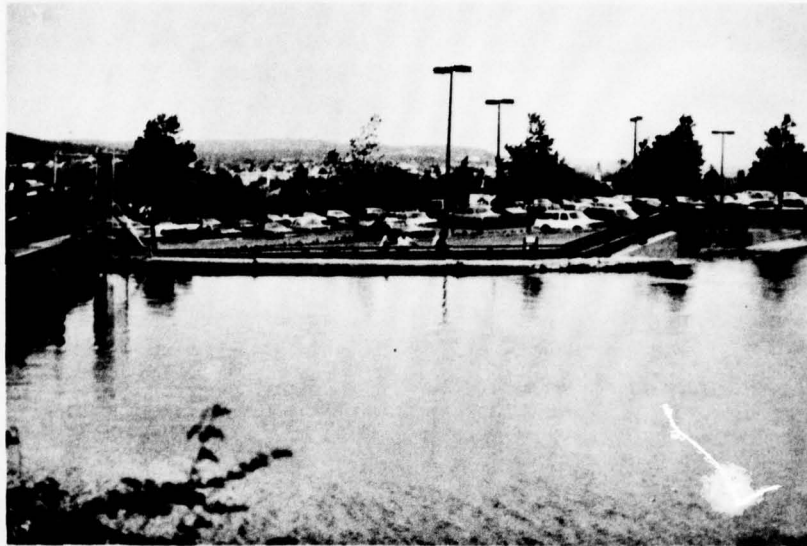
Photo 3 - View of dam and bank parking lot below dam.

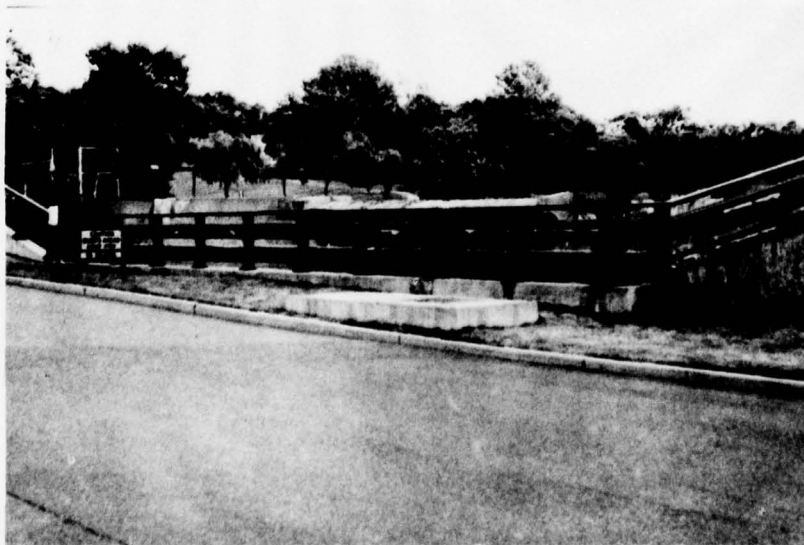
Photo 4 - View of dam from bank parking lot. Dam is partially hidden by guard railing on parking lot retaining wall.

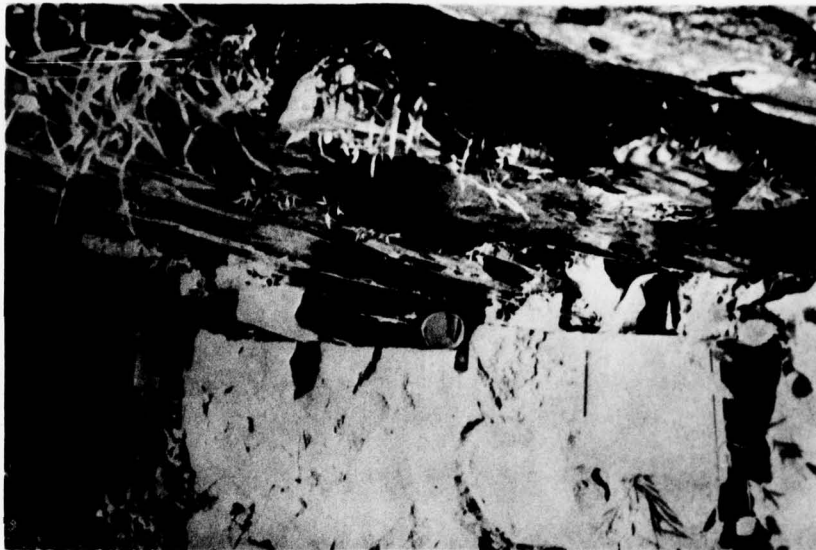
A prominent joint set exposed in the left abutment area strikes N5°E, and dips 80°SE and has a joint spacing of 1 to 3 feet. This joint set parallels a fault, mapped by others, about one-half mile east of the dam. Near the base of the dam, downstream of the left abutment, this prominent joint set is opened a maximum of 4 inches and average about 1-1/2 inches along a joint trace of 25 feet. (This feature is believed to be due to stress relief.) The rock in this area is broken by two additional joint sets mutually perpendicular, irregularly spaced (average-3 feet) and having variable trace lengths (average-less than 1 foot).

Photo 6 - View of joint in rock located in left abutment of dam.

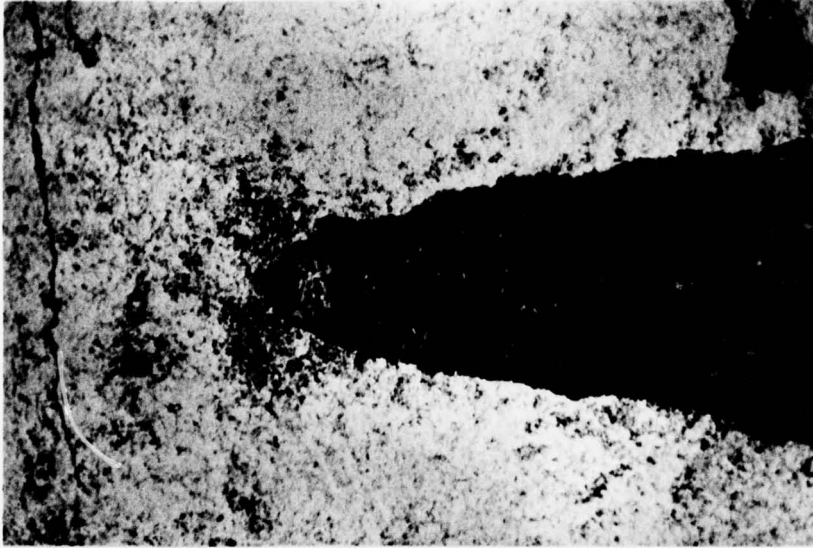
The face of the dam consisted of 2 to 6 inches of gunite with a grid of 1 inch diameter weep holes, many of which were discharging small quantities of clean water. It was determined, from an area where the gunite had broken away, that the original face of the dam was brick. The brick in this location, about four tenths of the height of the dam from the base at the right abutment, had become very loose at its contact with the abutment. A void, about 10 inches deep, has developed behind the gunite in this area. Considerable spalling of the gunite has occurred, particularly near the right abutment.

Photo 8 - Drain hole in gunitite facing on downstream face of dam.

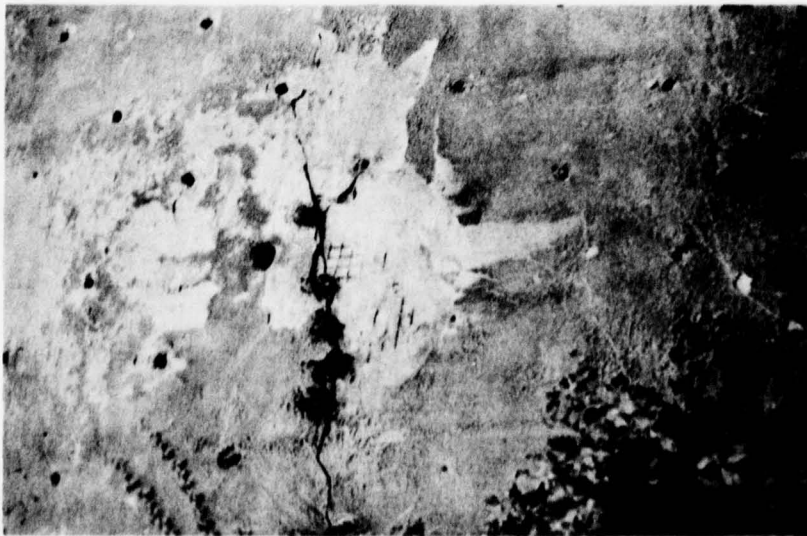
VISUAL EXAMINATION OF	OBSERVATIONS	REMARKS OR RECOMMENDATIONS
SURFACE CRACKS CONCRETE SURFACES	Considerable spalling of gunite coating, especially near right abutment. Gunite coating varies from 2 to more than 6 inches. Severe spalling at top of concrete cap.	Loose gunite should be re-moved and repaired. See note previous page.
STRUCTURAL CRACKING	Structure hidden by gunite. Crack of no significance is evident at bottom of concrete cap slab.	
VERTICAL AND HORIZONTAL ALIGNMENT	No evidence of movement of structure can be found.	
MONOLITH JOINTS	None visible.	
CONSTRUCTION JOINTS	None visible.

Photo 9 - Drain holes and exposed wire mesh under spalled gunite.

The deteriorated facing of the dam should be repaired.

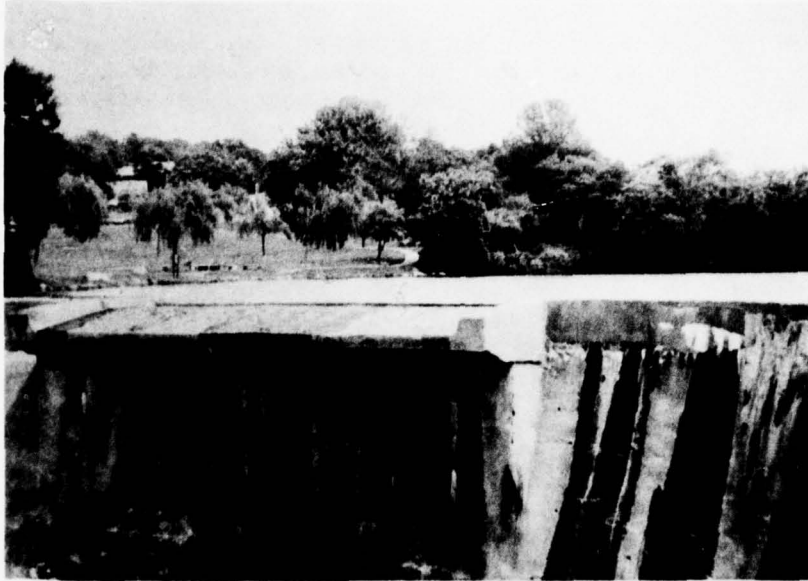
Photo 11 - Main spillway and right shoreline.

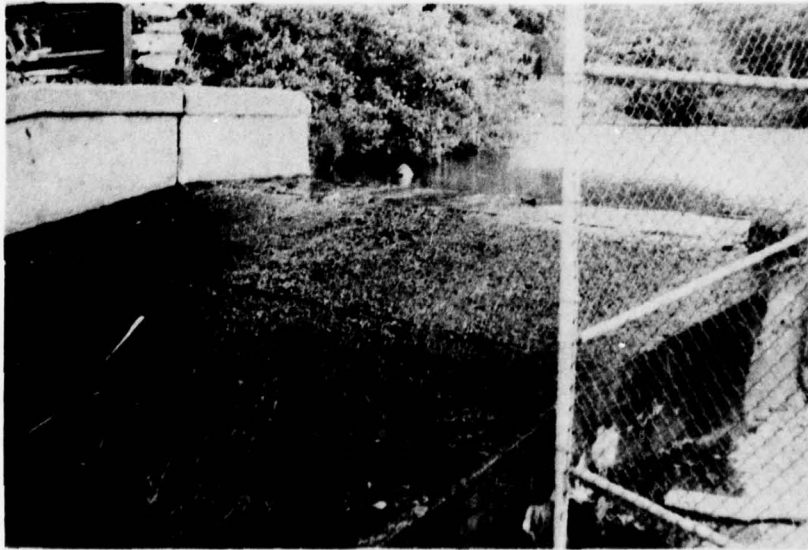
Photo 12 - Service spillway from downstream.

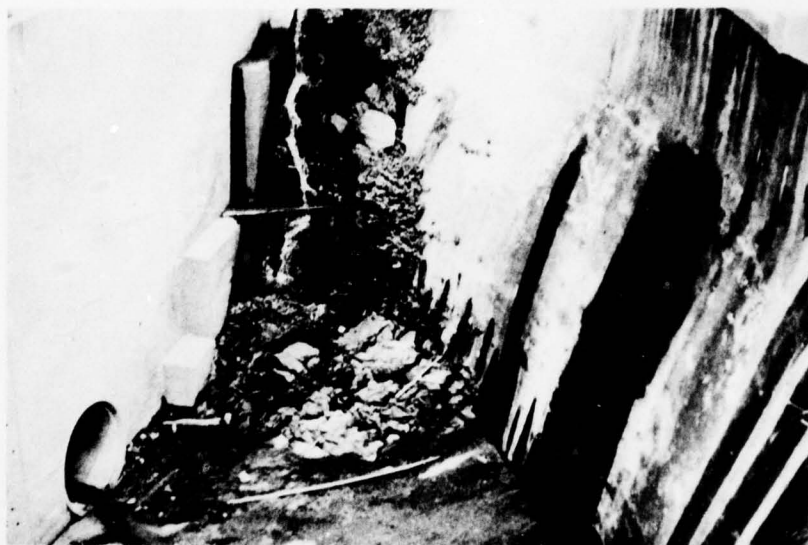
Photo 13 - View of dam, bottom slab under main spillway, retaining wall and discharge culvert under parking lot.

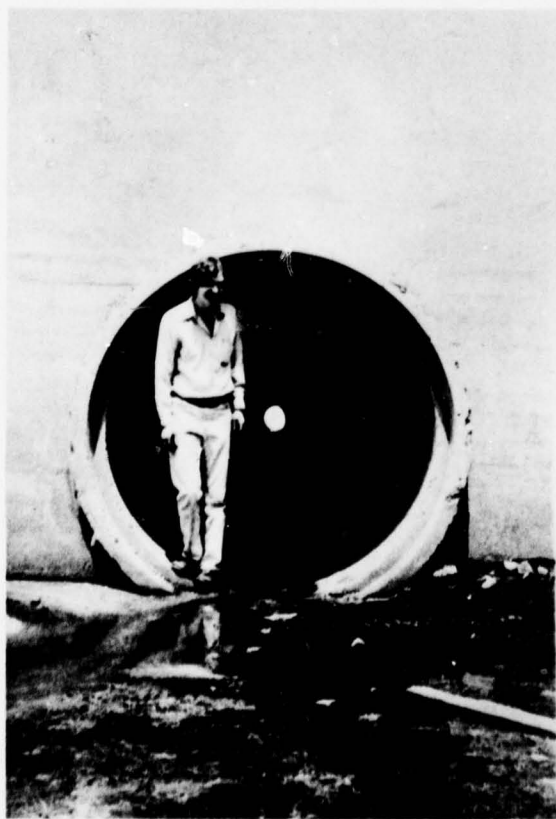
Photo 14 - Inlet and 6 ft. diameter concrete pipe discharge culvert.

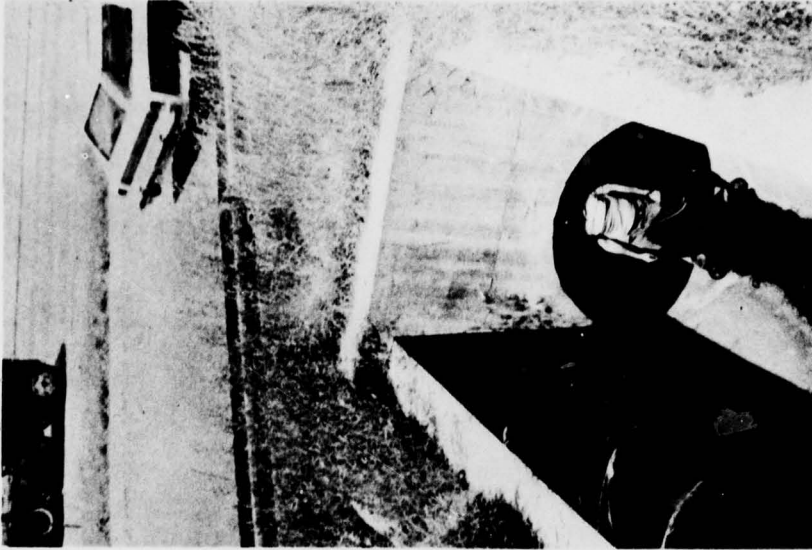
Photo 16 - Inlet to 6 ft. diameter culvert  
under Highway 80.

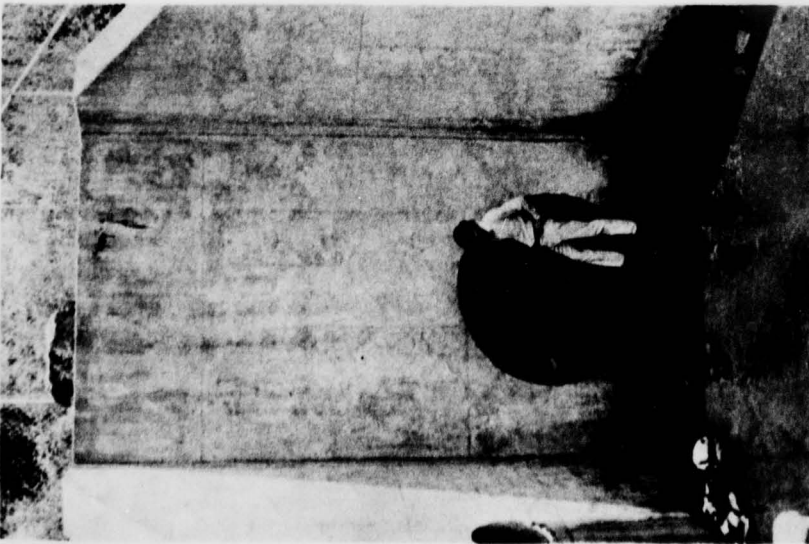
Photo 15 - Outlet structure for parking lot  
culvert.

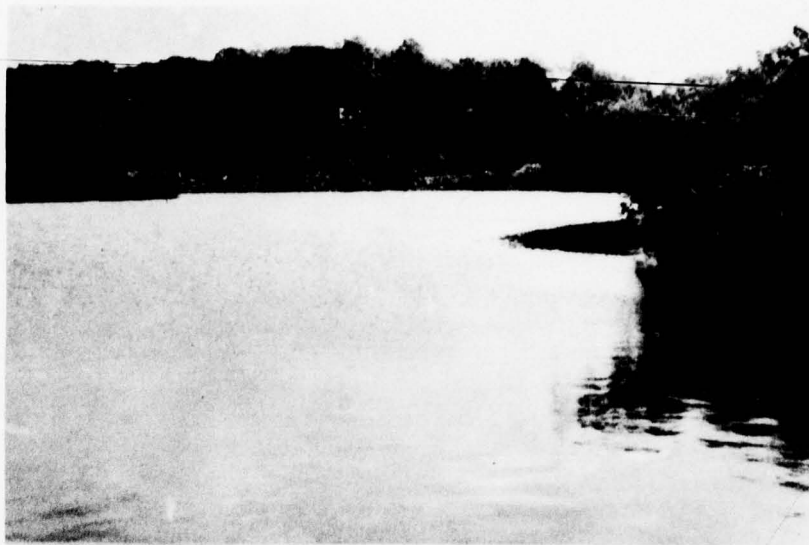
Photo 17 - View of Highland Lake from right abutment showing  
barrage built from bank excavation and forming  
small upper impoundment.
